INSPECTION REPORT				Report No: 02	Date: 2-18-2012	Page 1 of 4	
CUSTOMER DATA					INTERTEK MOODY DATA		
Name:	CHINA PETROLEUM ENG & CONSTR CORP (CPECC)			Intertek Moody Project No.	NA		
Address:	28, Gu Lou Wai Da Jie, Dongcheng District, Beijing			Client P.O./I.O. to Intertek Moody:	TPI-2011-370-Moody		
Attn:	Li Guoqiang	Phone:	010-58192244		Requisition No:	NA	
E-Mail :	liguoqiang@cpecc.com.cn			Date of Order:	NA		
Copies to:	MI CHINA			Intertek Moody Contract Coordinator:	Huang Bei		
SUPPLIER/SUB-SUPPLIER DATA					INSPECTION INFORMATION		
Inspection Performed: <input type="checkbox"/> With Customer Supplier <input checked="" type="checkbox"/> With Sub-Supplier					Date(s) of Visit(s):		
P.O. No:		Change No:		Requisition No:		18 Feb. 2012	
P/HYFO-INT-10008-001		NA		NA		Date of Previous Visit: 9 Feb. 2012	
Supplier:	NA			Date of Next Scheduled Visit:		N/A	
Supplier Job No:	NA			P. O. Status:		<input checked="" type="checkbox"/> Complete <input type="checkbox"/> Incomplete

Location:	NA			Project Name:		IRAQ HALFAYA PROJECT Materials/Items Inspected: One Multi-Variable Flow Transmitter with 3 batteries	
Primary Contact:	NA						
Phone:	NA	E-mail :	NA				
Sub-supplier:	Shanghai Nuo Sh

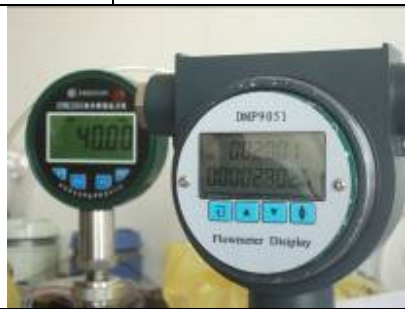
No.3

See picture No. 3, the local display meet the requirements Flow rate 6-digits and total 9-digits, acceptable.

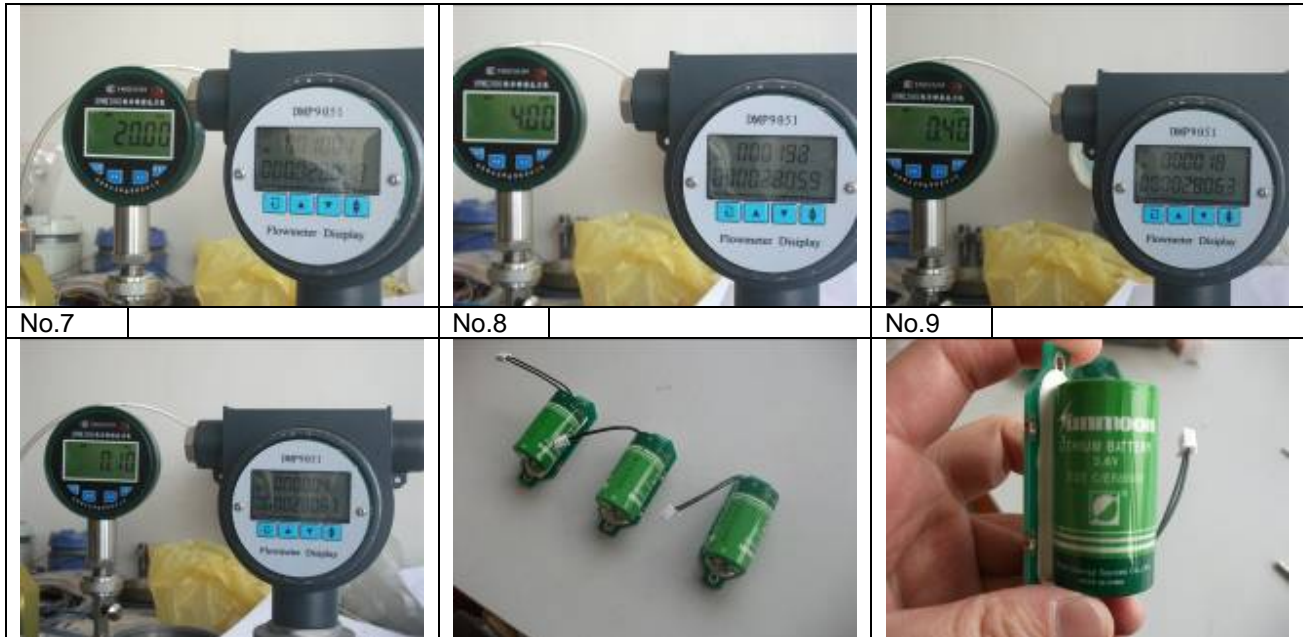
No.4		No.5		No.6

6.1	<u>Documents review</u> Reviewed the documents mentioned in clause 3.0.
6.2	<u>Battery inspection</u> Reviewed the ER26500 Battery Instruction and visual inspection for the battery, see Picture No. 8~9, and the parameter and performance meet the requirements, acceptable.

The accuracy test was witnessed, see picture No. 4-7, the accuracy can reach $\pm 0.1\%$ and it higher than the requirement 0.5%, test record for details see the attachment IAttachment01 DMP9051-A Multi-variable flow transmitter Accuracy Test record.pdf
